**UNITED STATES ENVIRONMENTAL PROTECTION AGENCY
REGION 1
1 CONGRESS STREET, BOSTON, MA 02114**

MEMORANDUM

DATE: May 14, 2013

SUBJ: CWA Complaint Inspection at Russell F. Tennant Water Treatment Facility, Attleboro, MA

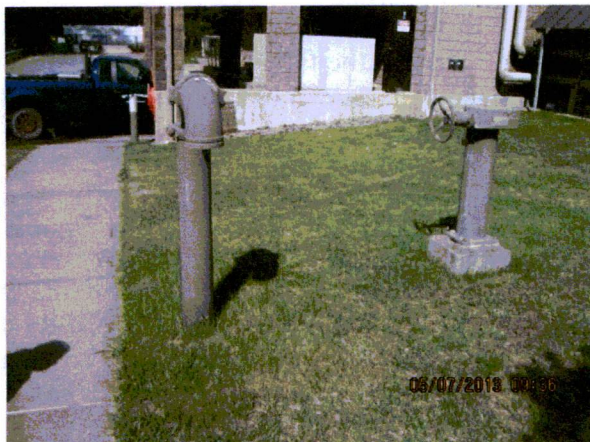
Photograph 1

The Inspection Team re-focused their attention on the aboveground vents and associated operating valves at this location (See Photographs 1 and 2). Ms. Wenschell stated that two (2) underground tanks were located at this area and were used to store the filter backwash from the GAC. The Inspection Team asked Ms. Millhouse if there were any bypasses that could divert filter backwash before or after these tanks. Ms. Millhouse stated that there were no bypasses and told the Inspection Team that the filter backwash flowed directly from the GAC to these tanks and, from there, to the pretreatment tank (See Photograph 3). Ms. Millhouse stated that the filter backwash was recycled at the headworks of the plant.

Vent pipe and tank valve associated with one of the two underground storage tanks located at this area and used to stored filter backwash generated by the GAC. The filter backwash water collected in these tanks are returned to the pretreatment tank and recycled back into the system.

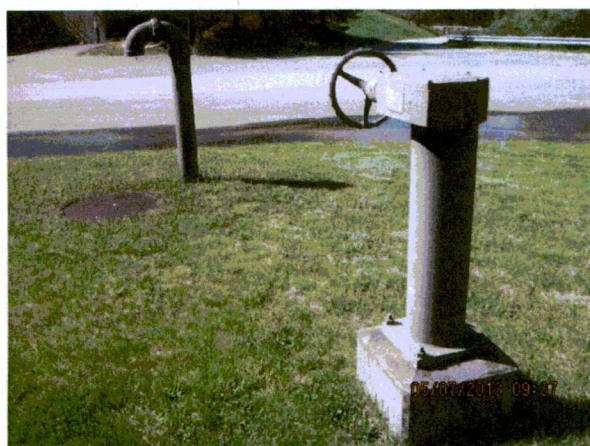
Photograph 2

Photograph of vent pipe, control valve and manhole access to one of the underground storage tanks used to store filter backwash waste stored prior to pretreatment. Water discharged from the Basin #1 of the Pretreatment Tank is visible in the foreground.

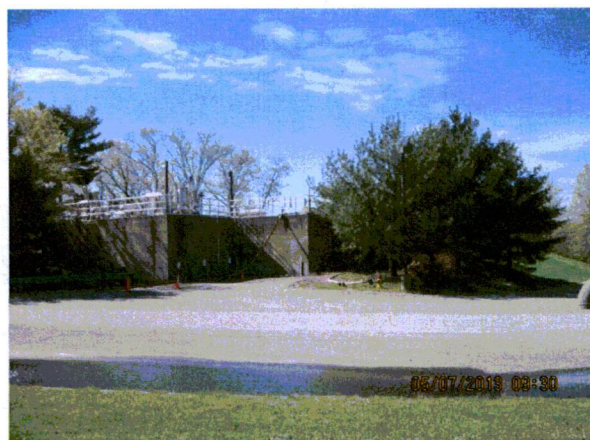
Photograph 3

View of the pretreatment tank located directly across the road from the two underground storage tanks used to collect filter backwash waste from the GAC. In the foreground of this photograph is the active discharge of supernatant from the pretreatment tank system (Basin #1). The fire hose is visible on the right side of the pretreatment tank and can be observed hanging from the structure before reaching the ground (marked off by the orange cones in this photograph).

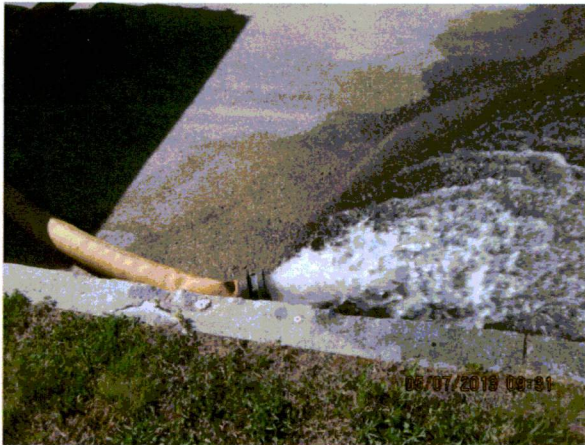
Photograph 4

Discharge of the process water from Basin #1 of the Pretreatment Tank (identified as "raw water" by Water Superintendent, Christine Millhouse). The other end of the yellow hose (not photographed) is located and was observed inside Pretreatment Tank, Basin #1.

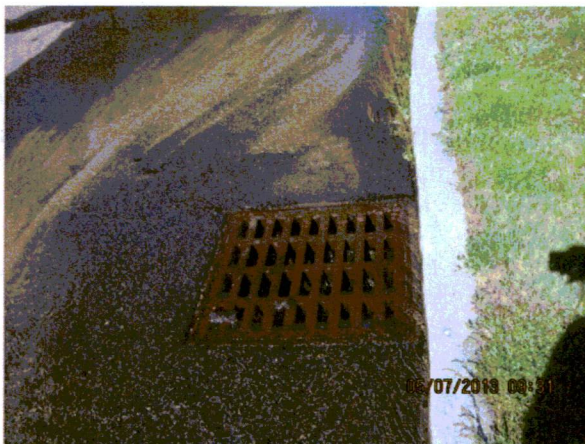
Photograph 5

Storm drain located next to the fire hose collected the process waters discharged from Basin #1 of the pretreatment tank.

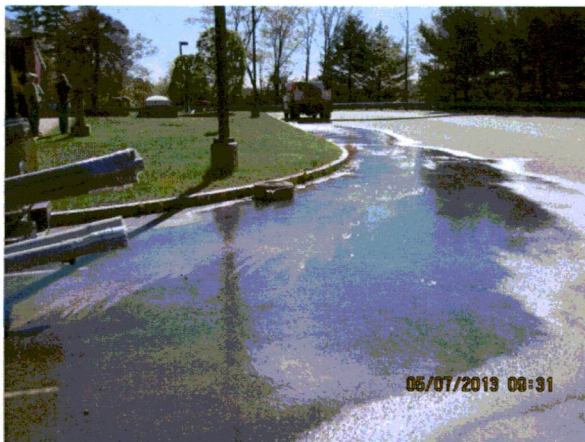
Photograph 6

Process water discharge (note hose line across the road) flowing past the storm drain photograph in Photograph 5 above, down gradient on asphalt paving past

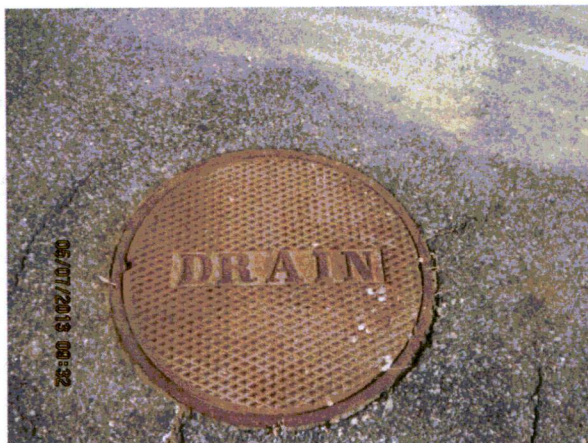
Photograph 7

Photograph of a manhole cover marked "DRAIN" that was located along the path of the process water discharge.

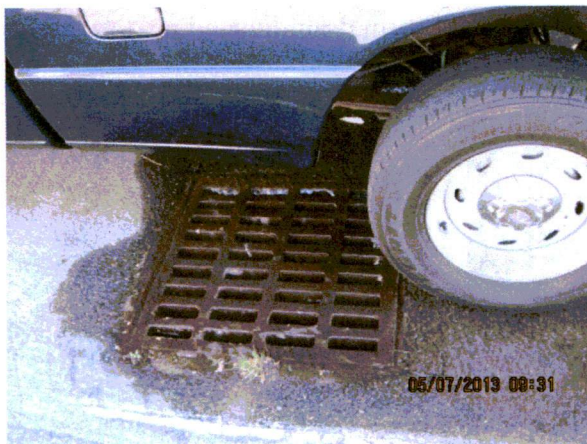
Photograph 8

Storm drain located down gradient from the fire hose and was the final drainage system entry point for pretreatment process waters that did not enter the access points shown in photographs 5 and 7 above.

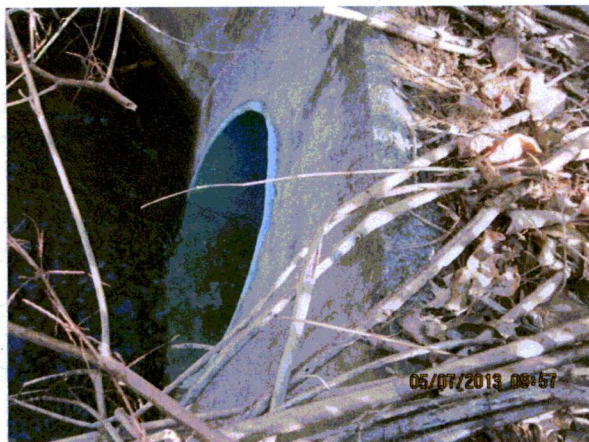
Photograph 9

Process water discharge from the stormwater collection system entering the retention pond.

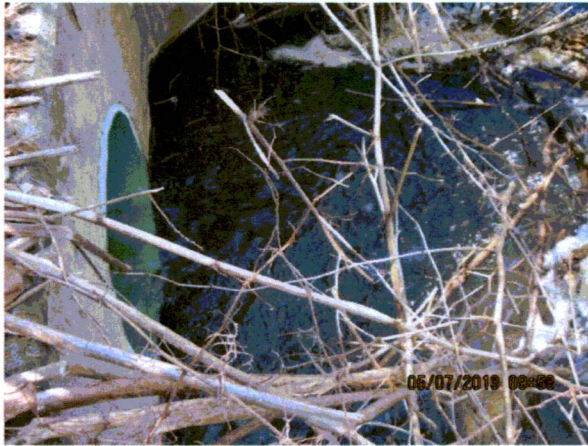
Photograph 10

Process water discharge from the storm water collection system entering the retention pond (different angle).

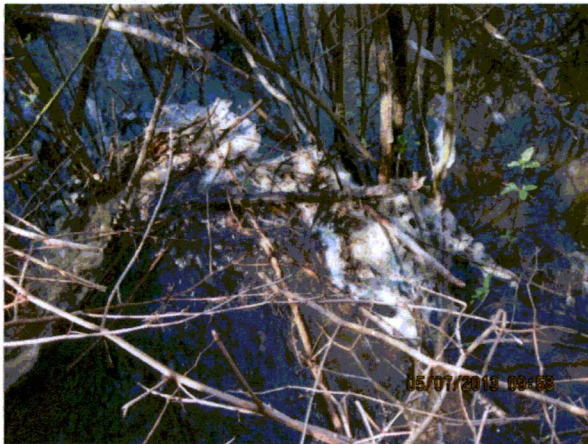
Photograph 11

Photograph of the discharge from the storm water collection system into the retention pond (the discharge pipe shown in Photographs 9 and 10 is located off the photograph at the bottom left side)

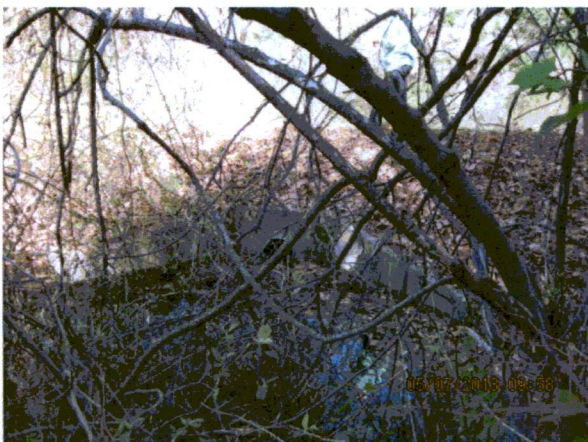
Photograph 12

Photograph of the concrete headwall and PVC pipe exiting the retention pond through the berm of the pond to Orr's Pond, located on the opposite side of the berm.

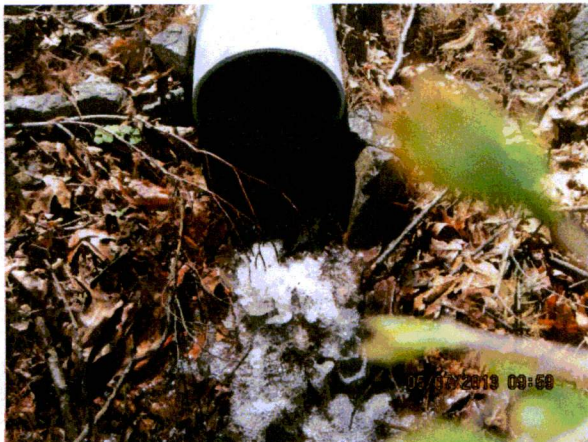
Photograph 13

PVC pipe (shown exiting the retention pond in Photograph 12) discharging process waters from the retention pond (to Orr's Pond).

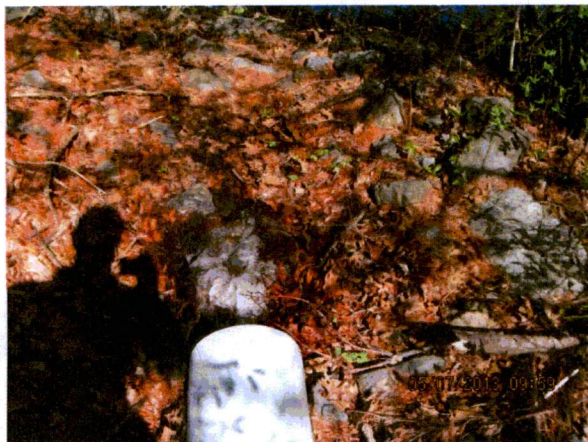
Photograph 14

Process water discharge from the retention pond to the ground and overland into Orr's Pond (Orr's Pond is visible at the top right of the photograph).

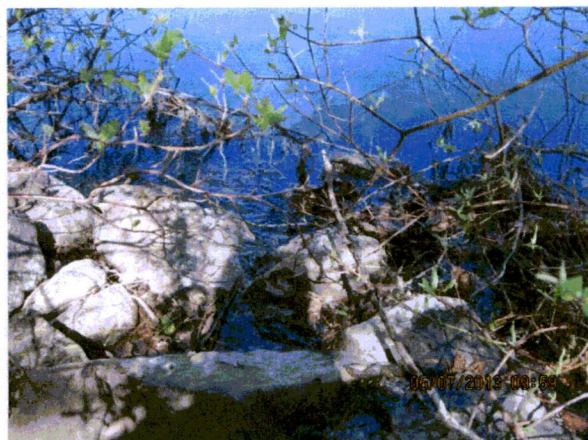
Photograph 15

Process water discharge from retention pond outfall pipe flowing directly into Orr's Pond.

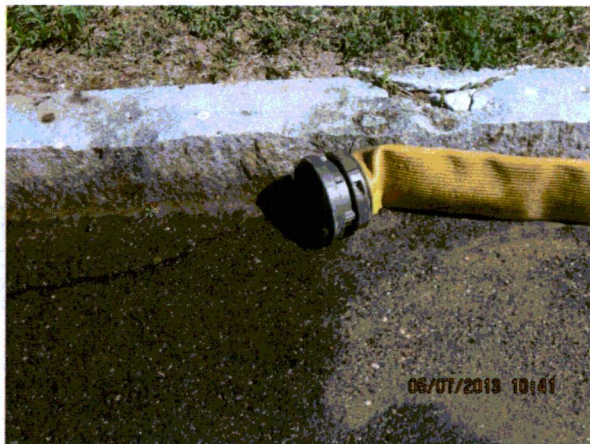
Photograph 16

Photograph of process water discharge from the pretreatment tank terminated after samples were collected for analysis.
